PHASE I ENVIRONMENTAL SITE ASSESSMENT

16 SEPTEMBER 2020

SAN RAFAEL TRANSIT
CENTER PROJECT
San Rafael, California

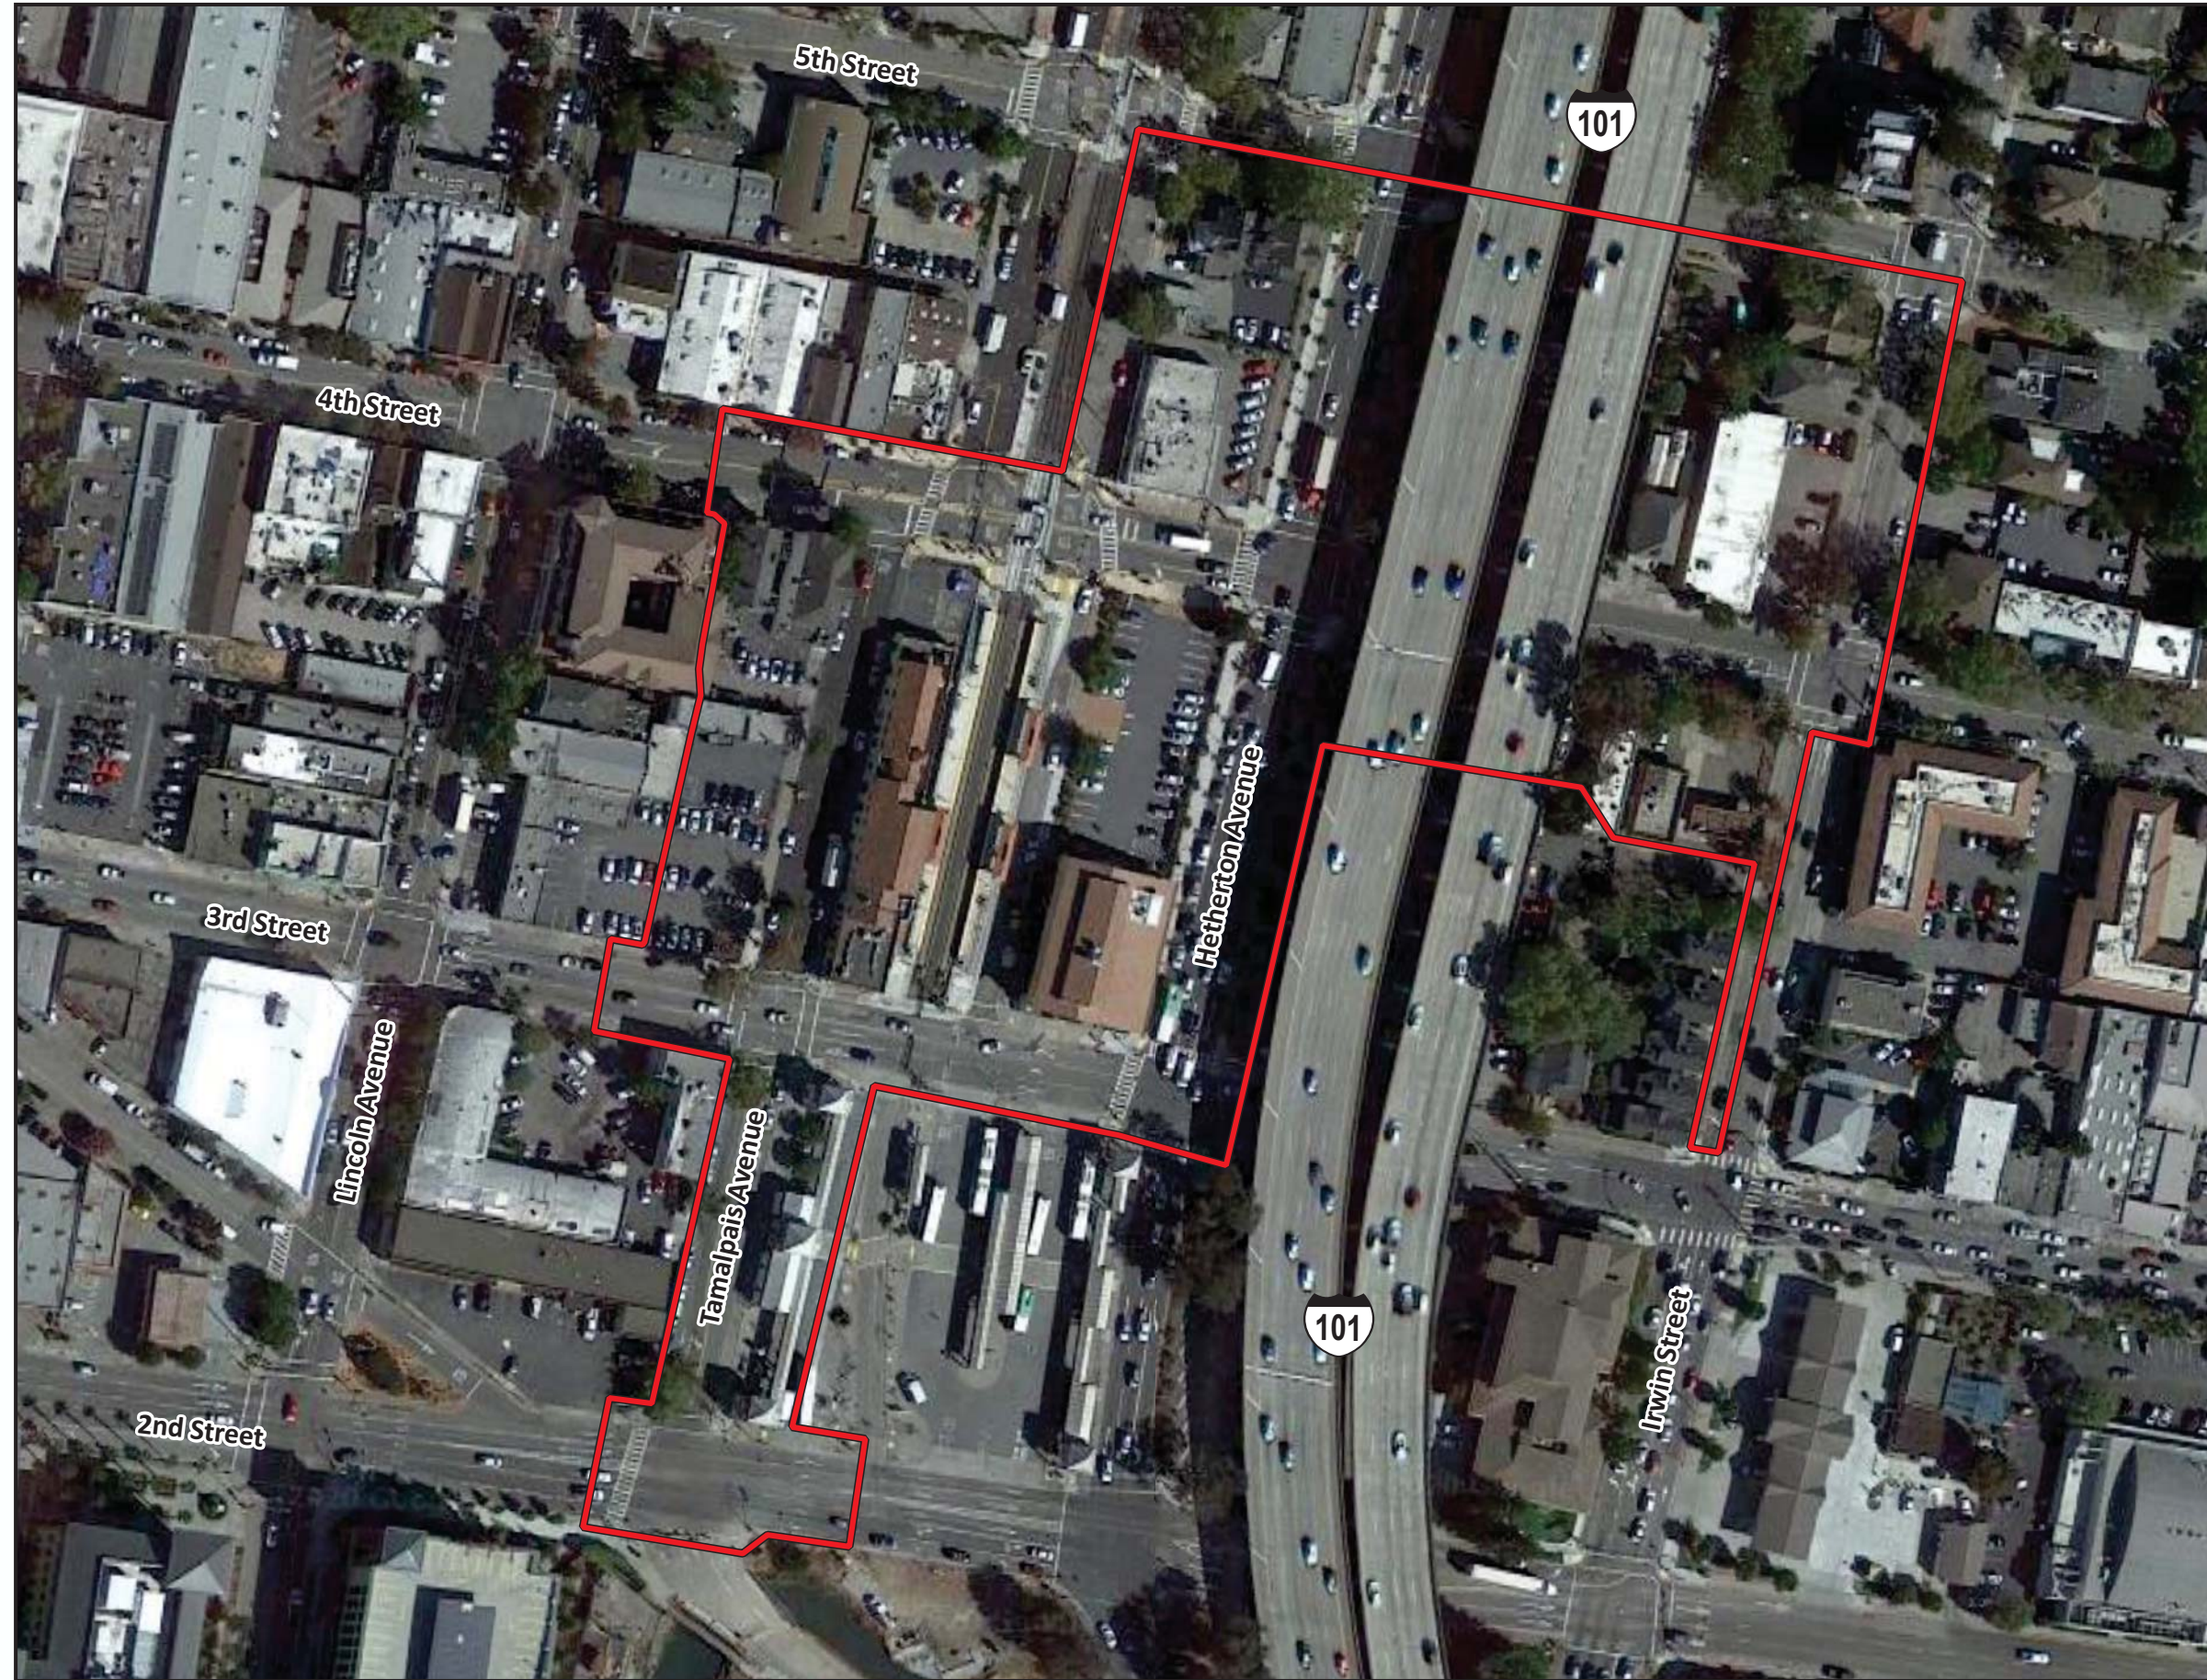
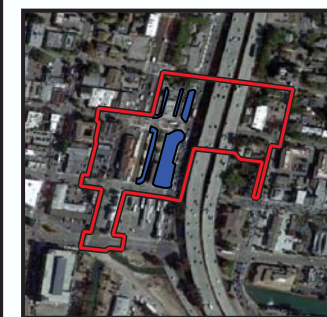
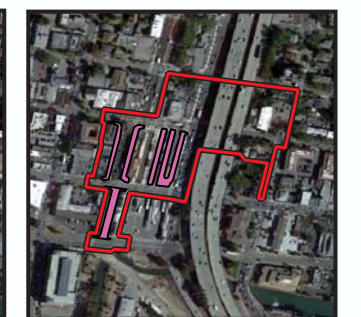
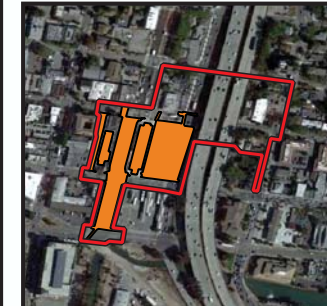
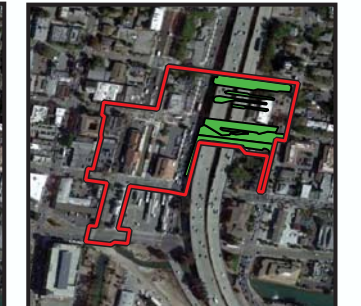
Project Build Alternatives

4th Street Gateway Alternative

Whistlestop Block Alternative

Move Whistlestop Alternative

Under the Freeway Alternative

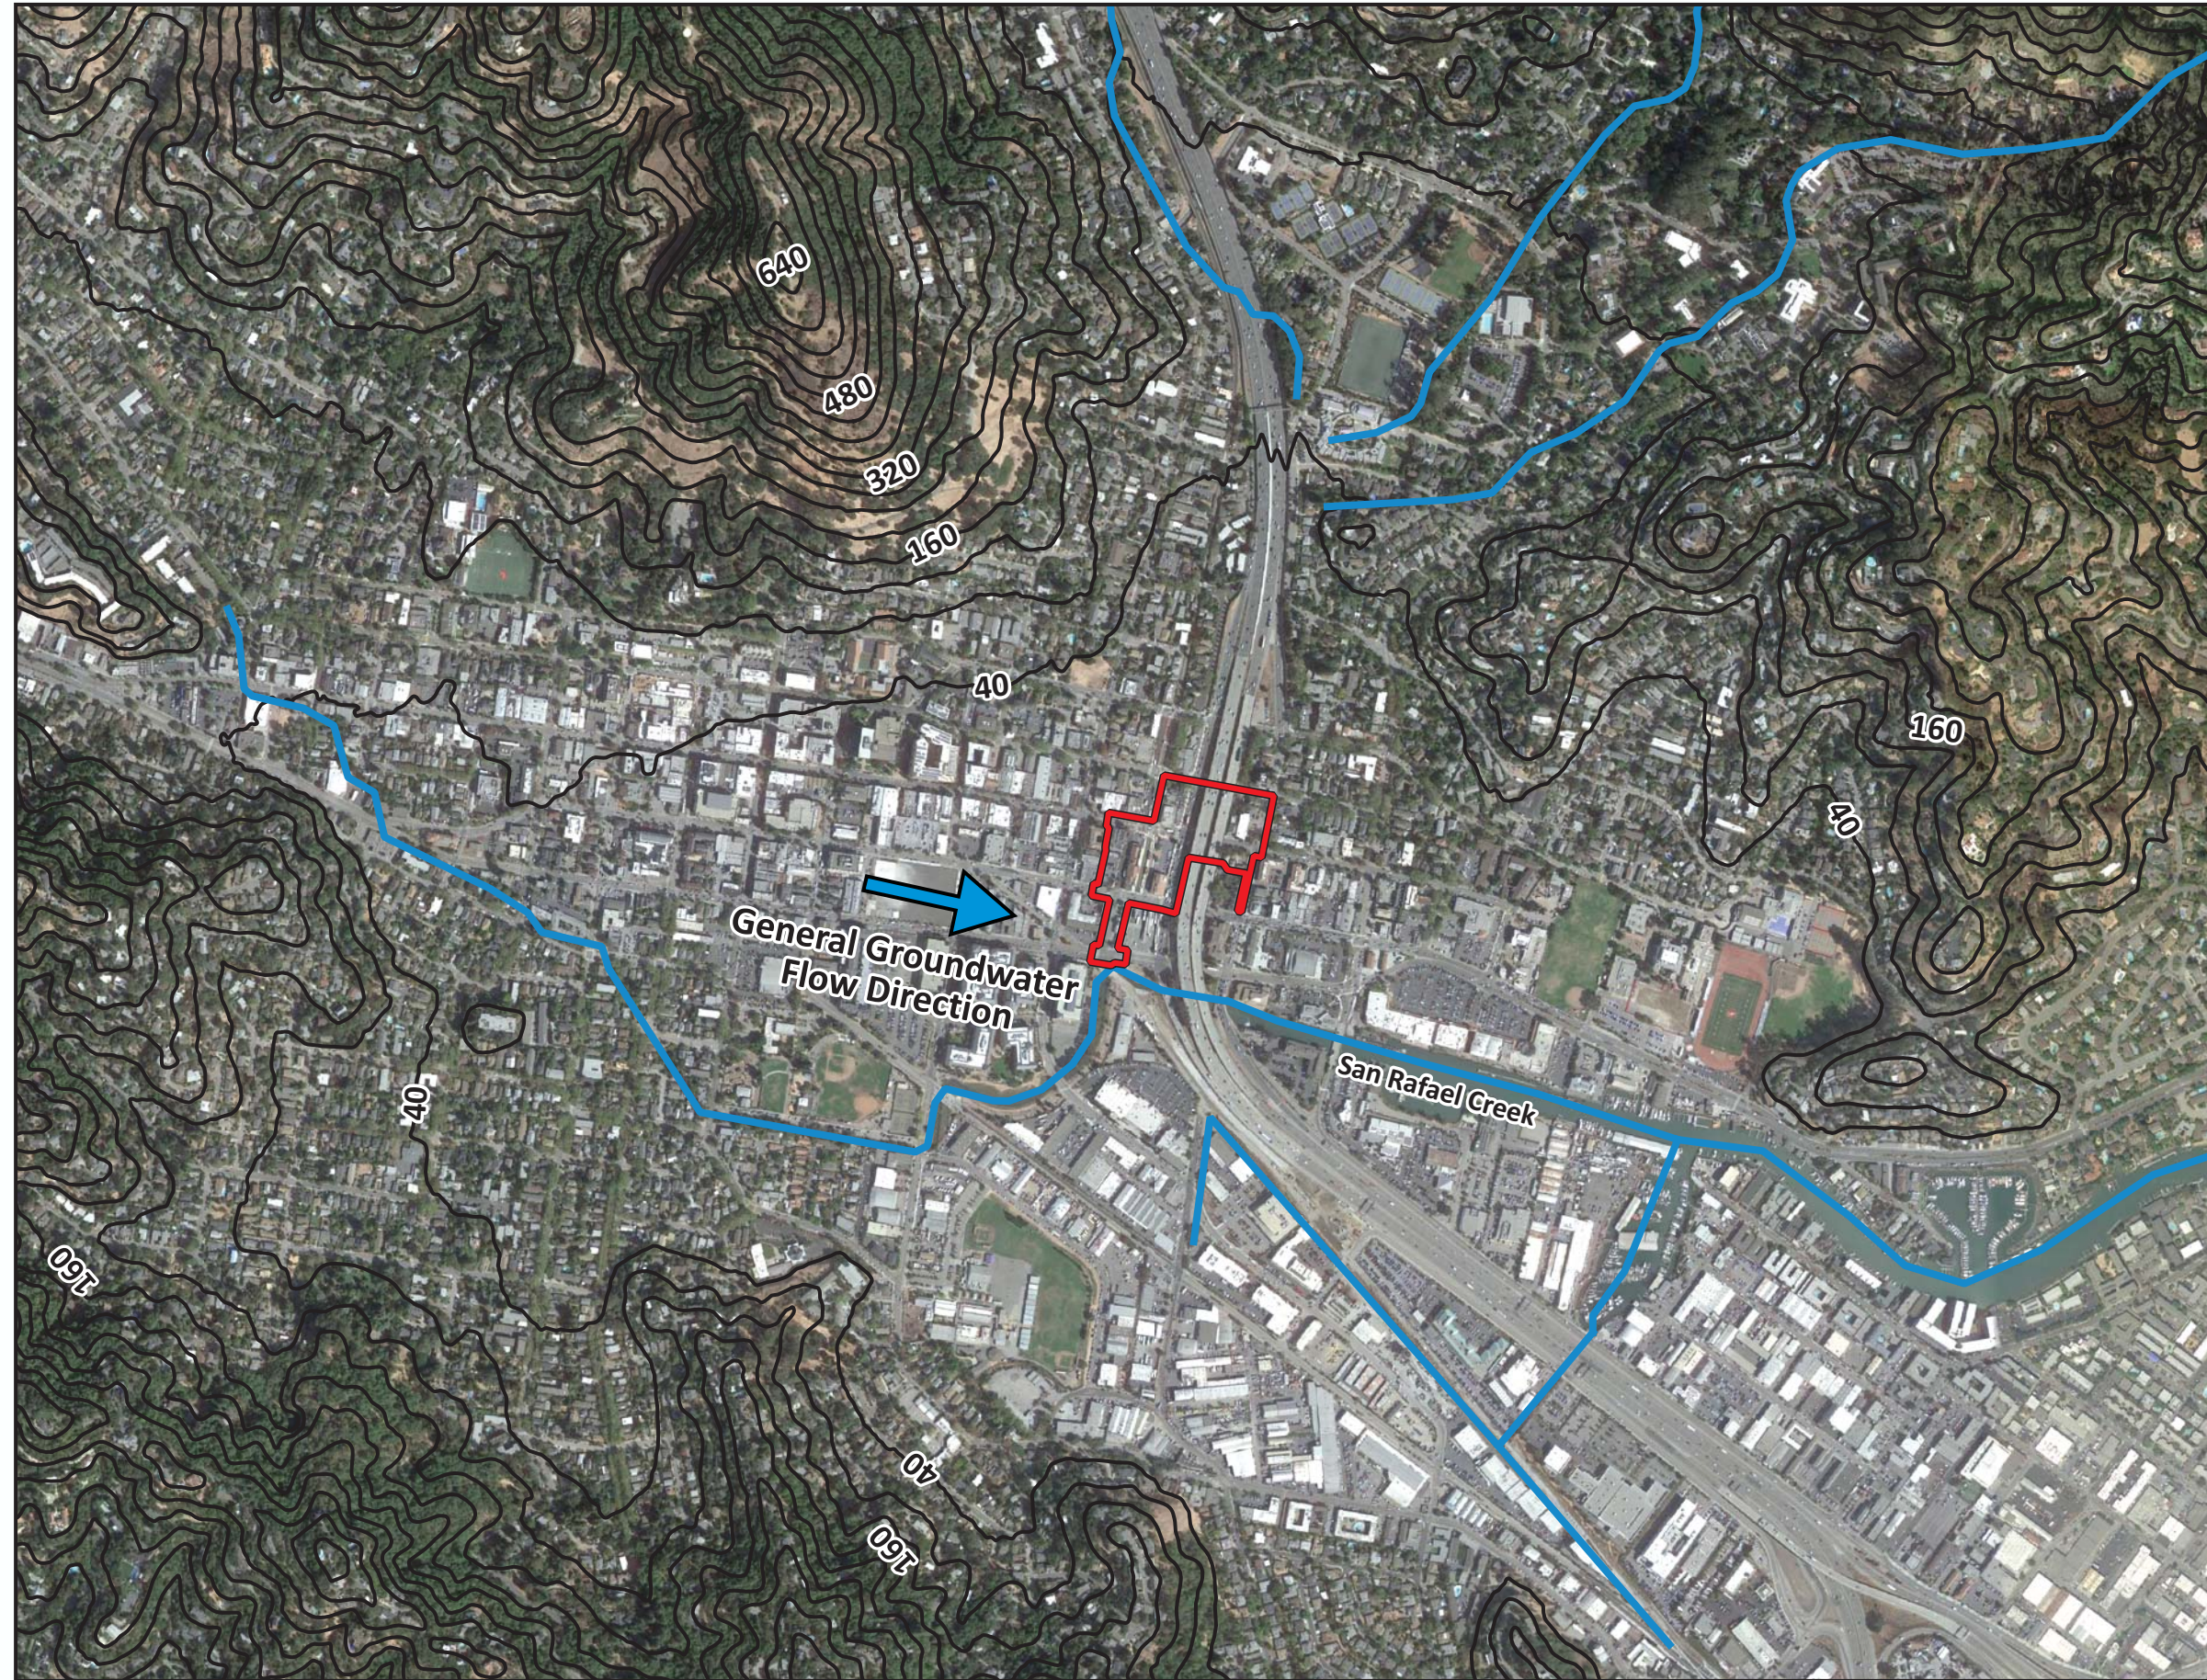
The project is primarily located on Holocene alluvium adjacent to the San Rafael Creek (Graymer, R.W, et al., 2006), which drains east into the San Francisco Bay about 1.5 miles from the project study limits. The project area is relatively flat with an average elevation of about 10 feet relative to the North American Vertical Datum of 1988 (NAVD88) (USGS, 2018). Based on review of previous groundwater investigations performed near the project study limits (ETIC, 2020), the groundwater ranges in depth from about 3 to 6 feet below ground surface and generally flows east-southeast towards the San Rafael Creek (**Figure 3**). However, local groundwater elevations and flow directions within the project study limits could potentially be tidally influenced (i.e., variable over time) based on the proximity to the San Francisco Bay.

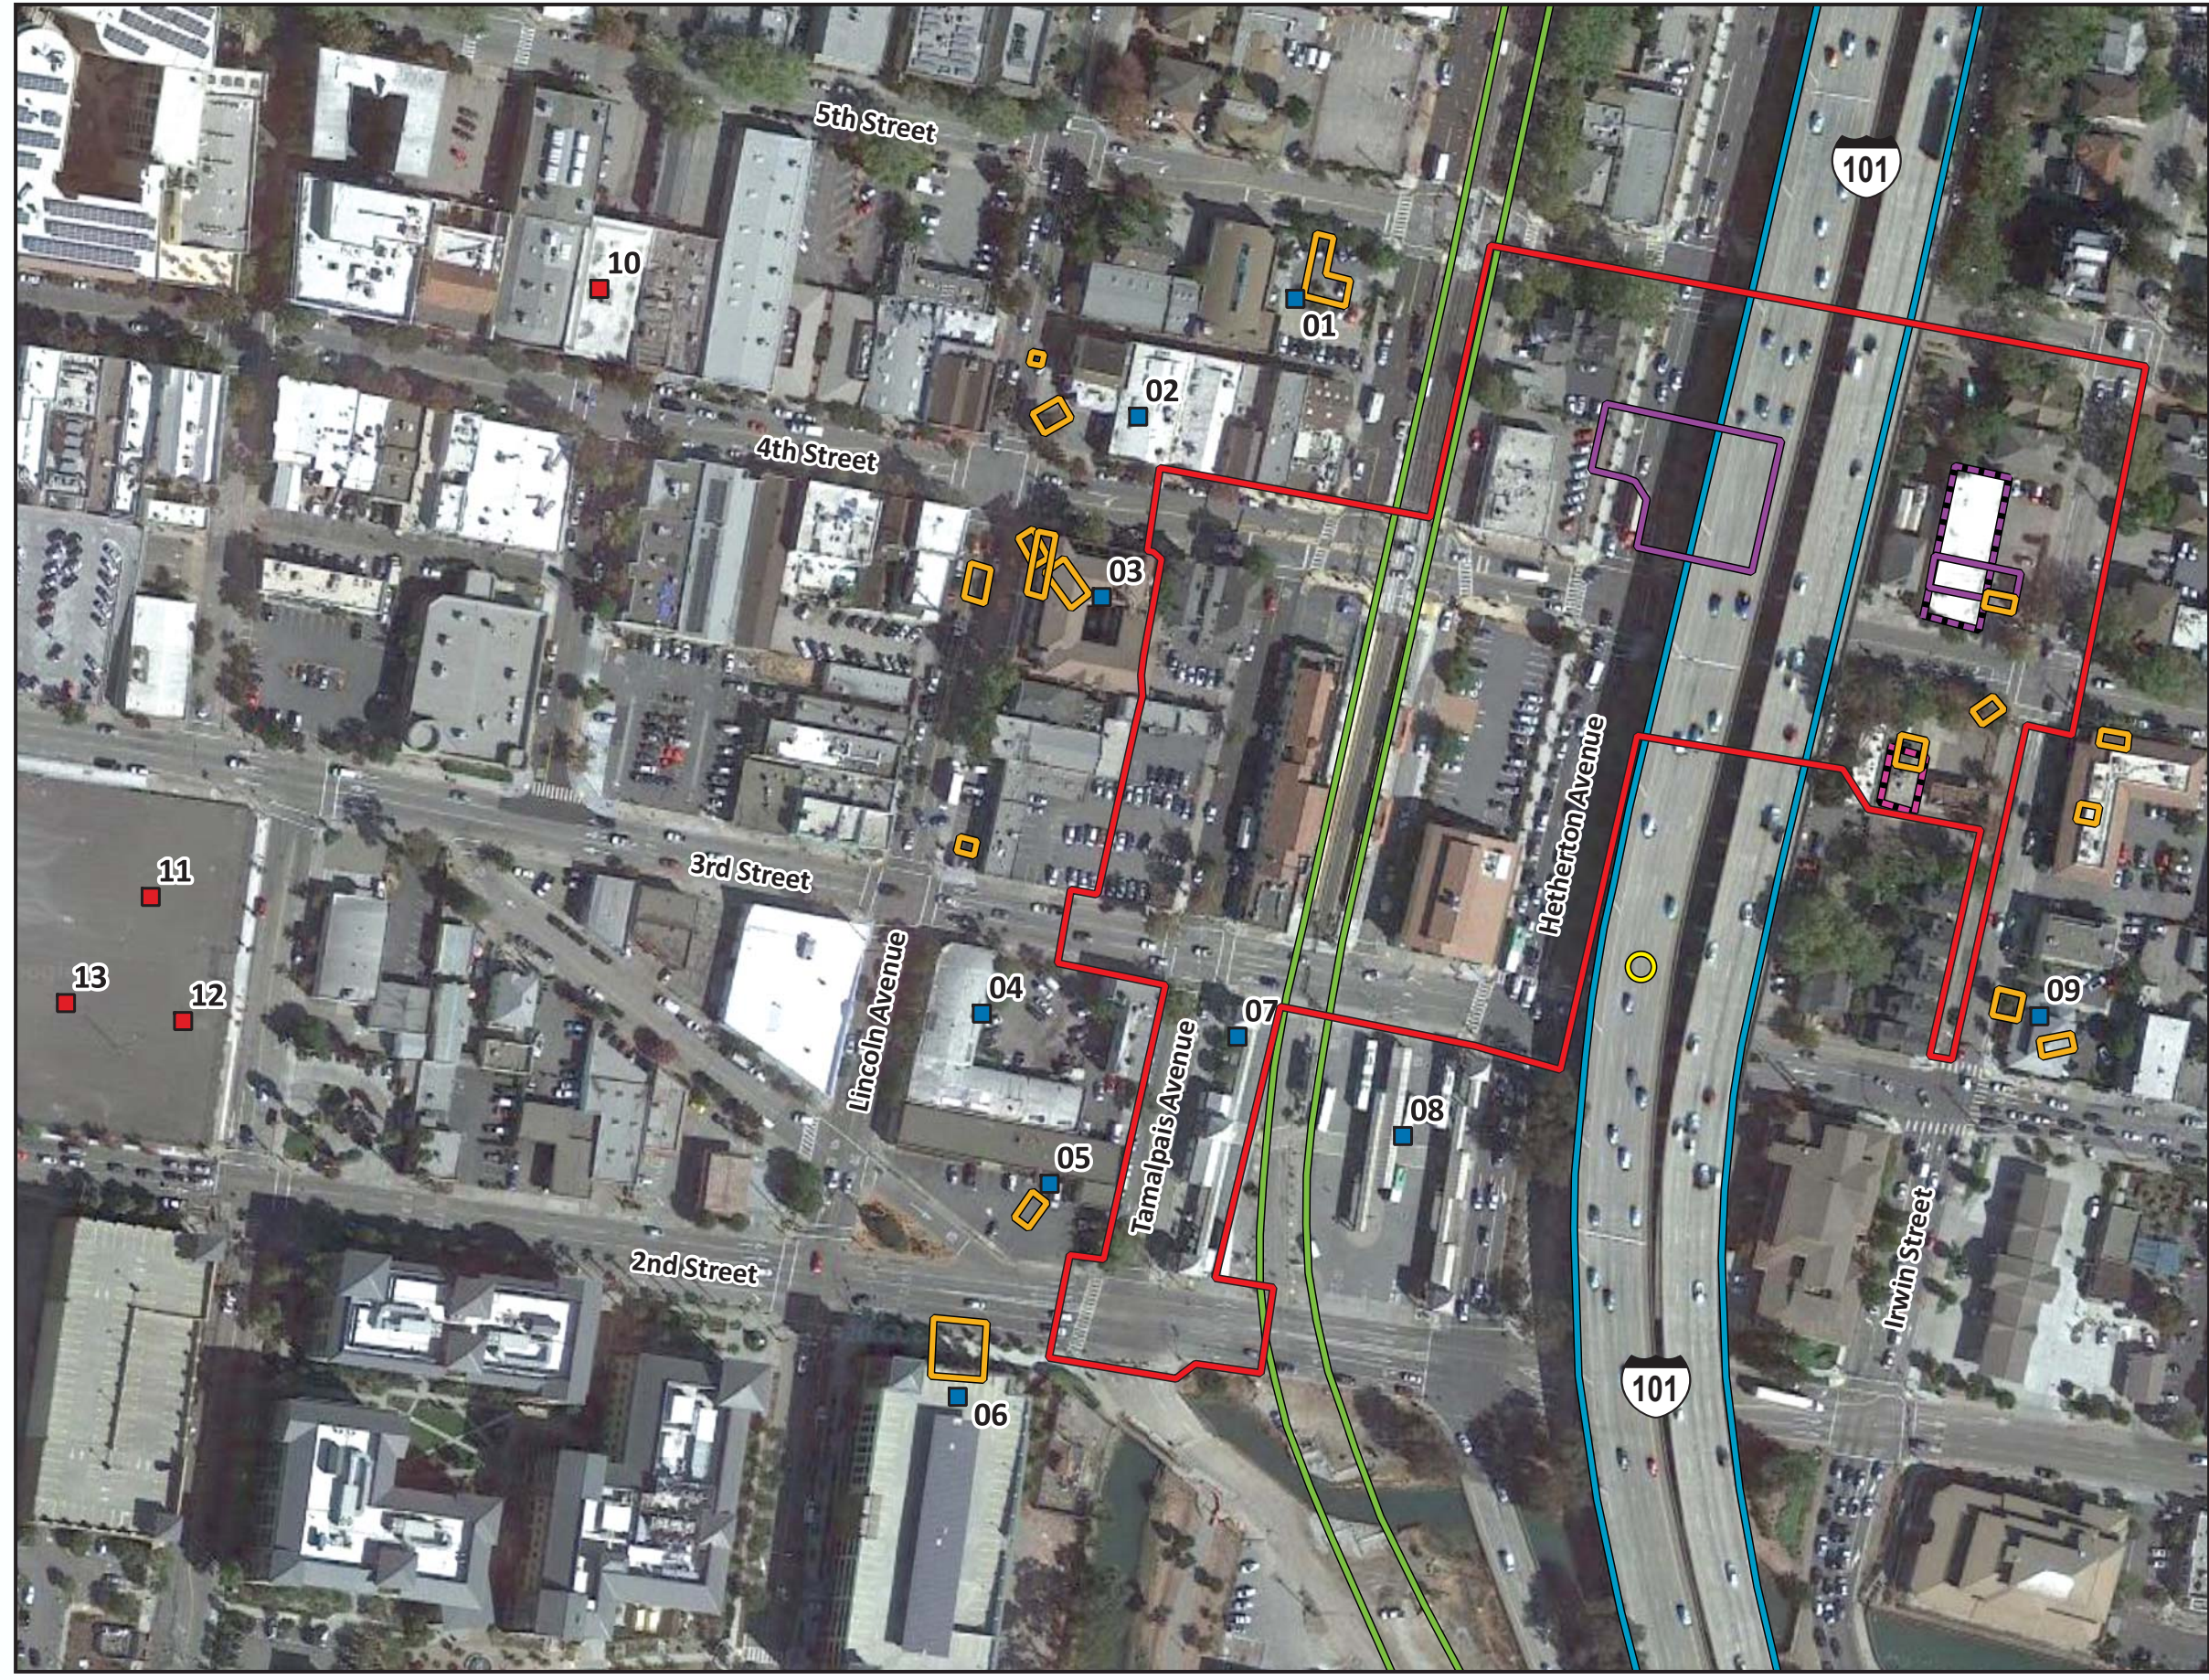
As early as 1924, land uses developed within the project study limits included residential dwellings, a hotel, lumber yard, train station, and railroad corridor. Two gasoline service stations were located adjacent to the project study limits (**Figure 4 and Appendix A**). Between 1924 and 1950, the railroad corridor and station operations expanded, the U.S. Highway 101 viaduct was constructed over the project study limits, and additional land uses within the project study limits included a bus station, milk and creamery company, gravel company, and automotive repair services. Two additional gasoline service stations were located within the project study limits, six additional gasoline service stations were located adjacent to the project study limits, and one aboveground oil storage tank was located adjacent to the project study limits (**Figure 4 and Appendix A**). Between 1950 and 1970, the U.S. Highway 101 viaduct expanded, one additional gasoline service station was located within the project study limits, and six additional gasoline service stations were located adjacent to the project study limits (**Figure 4 and Appendix A**).

Since 1970, most of the automotive repair services and all of the gasoline service stations and the aboveground oil tank previously identified within and adjacent to the project study limits have been redeveloped primarily for residential and commercial uses. Based on the site reconnaissance conducted on 15 May 2020, there are two land uses currently located within the project study limits that appear to manage hazardous materials: an automotive repair service station and dry cleaner facility (**Figure 4**).

- A former gasoline service station (circa 1950) located adjacent to the project study limits at the northeast corner of the current Lincoln Avenue and 3rd Street intersection (**Figure 4**).
- A former automobile service building (circa 1950) located within the project study limits north of the current Hetherton Street and 4th Street intersection (**Figure 4**).
- A former aboveground oil storage tank for a gravel company (circa 1950) located adjacent to the project study limits to the northeast of the current Hetherton Street and 3rd Street intersection (**Figure 4**).
- Former automobile and gasoline service stations (circa 1950 and 1970) and a current automobile service station and dry cleaner building (2020) located within and adjacent

to the project study limits at the northwest, southwest, and southeast corners of the current Irwin Street and 4th Street intersection (**Figure 4**).

The Foodmart site (Site 01 on **Figure 4**), which is located adjacent to the project study limits, was formerly occupied by a gasoline service station. In 1994, a release of petroleum from leaking underground storage tanks (USTs) was reported following tank removal activities at the site. In 1995, the case was closed by the lead regulatory oversight agency, the San Francisco Bay Regional Water Quality Control Board (Regional Water Board), because it did not appear that further monitoring, investigation or remedial actions were necessary to protect human health, safety, and the environment. According to the most recent groundwater monitoring event in 1995, no residual petroleum hydrocarbons were reported above laboratory reporting limits in the groundwater samples (San Rafael Fire Department, 1995). Therefore, groundwater contamination from the release site is not expected to affect environmental conditions within the project study limits.

In 1989, a release of petroleum from leaking USTs was reported following tank removal activities at the D&S Garage site (Site 02 on **Figure 4**), which is located adjacent to the project

The Former Chevron Station site (Site 03 on **Figure 4**), which is located adjacent to the project study limits, was formerly a gasoline service station. In 1987, a release of petroleum from leaking USTs was reported following tank removal activities at the site. In 1997, the case was closed by the lead regulatory oversight agency (Regional Water Board) because it did not appear that further monitoring, investigation or remedial actions were necessary to protect human health, safety, and the environment. According to the most recent groundwater monitoring results from 1990 to 1997, residual concentrations of petroleum were not reported in the groundwater monitoring wells located on the eastern portion of the site, which are within about 50 feet of the project study limits (San Rafael Fire Department, 1997). In 1998, an additional UST was discovered and removed from the western portion of the site. According to analytical results of soil and water samples collected during the tank removal, the extent of residual petroleum contamination adjacent to the former UST appeared to be limited; therefore, the regulatory case status has remained closed (Cambria, 1998). Based on the limited extent and age (over 20 years) of residual contamination on the western portion of the site, residual groundwater contamination from the release site is not expected to affect environmental conditions within the project study limits.

In 1988, a release of petroleum from leaking USTs was reported following tank removal activities at the John Irish Jeep Dealership site (Site 04 on **Figure 4**), which is located adjacent to the project study limits. In 1996, the case was closed by the lead regulatory oversight agency (Regional Water Board) because it did not appear that further monitoring, investigation or remedial actions were necessary to protect human health, safety, and the environment. According to the most recent groundwater sampling results in 1996, residual concentrations of toluene and MTBE were reported in groundwater samples collected in the immediate vicinity of the USTs about 200 feet west of the project study limits (San Rafael Fire Department, 1996a). Based on the proximity to the project study limits, residual groundwater contamination from the release site could potentially be encountered during project construction and maintenance.

In 1991, a release of petroleum and paint thinner from leaking USTs was reported following tank removal activities at the Marin Color Service site (Site 05 on **Figure 4**), which is located

The Shell site (Site 06 on **Figure 4**), which is located adjacent to the project study limits, was formerly a gasoline service station. In 1987, a release of petroleum from leaking USTs was reported following tank removal activities at the site. In 2009, the case was closed by the lead regulatory oversight agency (Regional Water Board) because it did not appear that further monitoring, investigation or remedial actions were necessary to protect human health, safety, and the environment. According to the most recent groundwater sampling results in 2008, residual concentrations of TPH-d and MTBE were reported in groundwater samples collected about 30 feet west of the project study limits (Conestoga-Rovers and Associates, 2008). Based on the proximity to the project study limits, residual groundwater contamination from the release site could potentially be encountered during project construction and maintenance.

On 8 November 1990, a release of petroleum from leaking USTs was reported at the Greyhound Line Inc. site (Site 07 on **Figure 4**), which appears to be located within the project study limits. About two weeks later the case was closed by the lead regulatory agency (Regional Water Board). Previous investigation and summary reports are currently not available for review on the SWRCB *GeoTracker* database. Because the release site appears to be located within the project study limits, residual contamination from the site (if any) could potentially be encountered during project construction and maintenance.

In 1990, a release of petroleum from leaking USTs was reported at the Savoy Rain Tunnel site (Site 08 on **Figure 4**), which is located adjacent to the project study limits. In 1996, the case was closed by the lead regulatory oversight agency (Regional Water Board) because it did not appear that further monitoring, investigation or remedial actions were necessary to protect human health, safety, and the environment. According to the most recent sampling results, residual concentrations of total petroleum hydrocarbons remain in the soil and groundwater near the former USTs (San Rafael Fire Department, 1996b). Based on the proximity to the project study limits, residual groundwater contamination from the release site could potentially be encountered during dewatering for project construction and maintenance activities.

The Exxon site (Site 09 on **Figure 4**), which is located adjacent to the project study limits, was formerly a gasoline service station. In 2003, the case was closed by the lead regulatory oversight agency (Regional Water Board) because it did not appear that further monitoring, investigation or remedial actions were necessary to protect human health, safety, and the environment. According to the most recent groundwater sampling results in 1997, residual concentrations of benzene and xylenes were reported in groundwater samples collected about 75 feet southeast of the project study limits (BACE Environmental, 1997). Based on the proximity to the project study limits, residual groundwater contamination from the release site could potentially be encountered during dewatering for project construction and maintenance activities.

The Former Grand Auto Store #9 site (Site 10 on **Figure 4**) is an active hazardous materials release site located about 500 feet west of the project study limits. In March 2019, a release of petroleum hydrocarbons and related impacts to soil was reported at the site. The site has since been inactive and previous investigation and summary reports are currently not available for review on the SWRCB *GeoTracker* database. Based on available information, soil contamination from the release site would not be expected to affect environmental conditions within the project study limits.

Based on a review of historical aerial photographs and Sanborn Fire Insurance maps (see Section 3.2), the U.S. Highway 101 viaduct within the study limits (**Figure 4**) was constructed as early as 1946, which was before the phase-out of lead in gasoline. Therefore, project construction and maintenance activities that disturb exposed shallow soils near the U.S. Highway 101 viaduct could encounter ADL contamination.

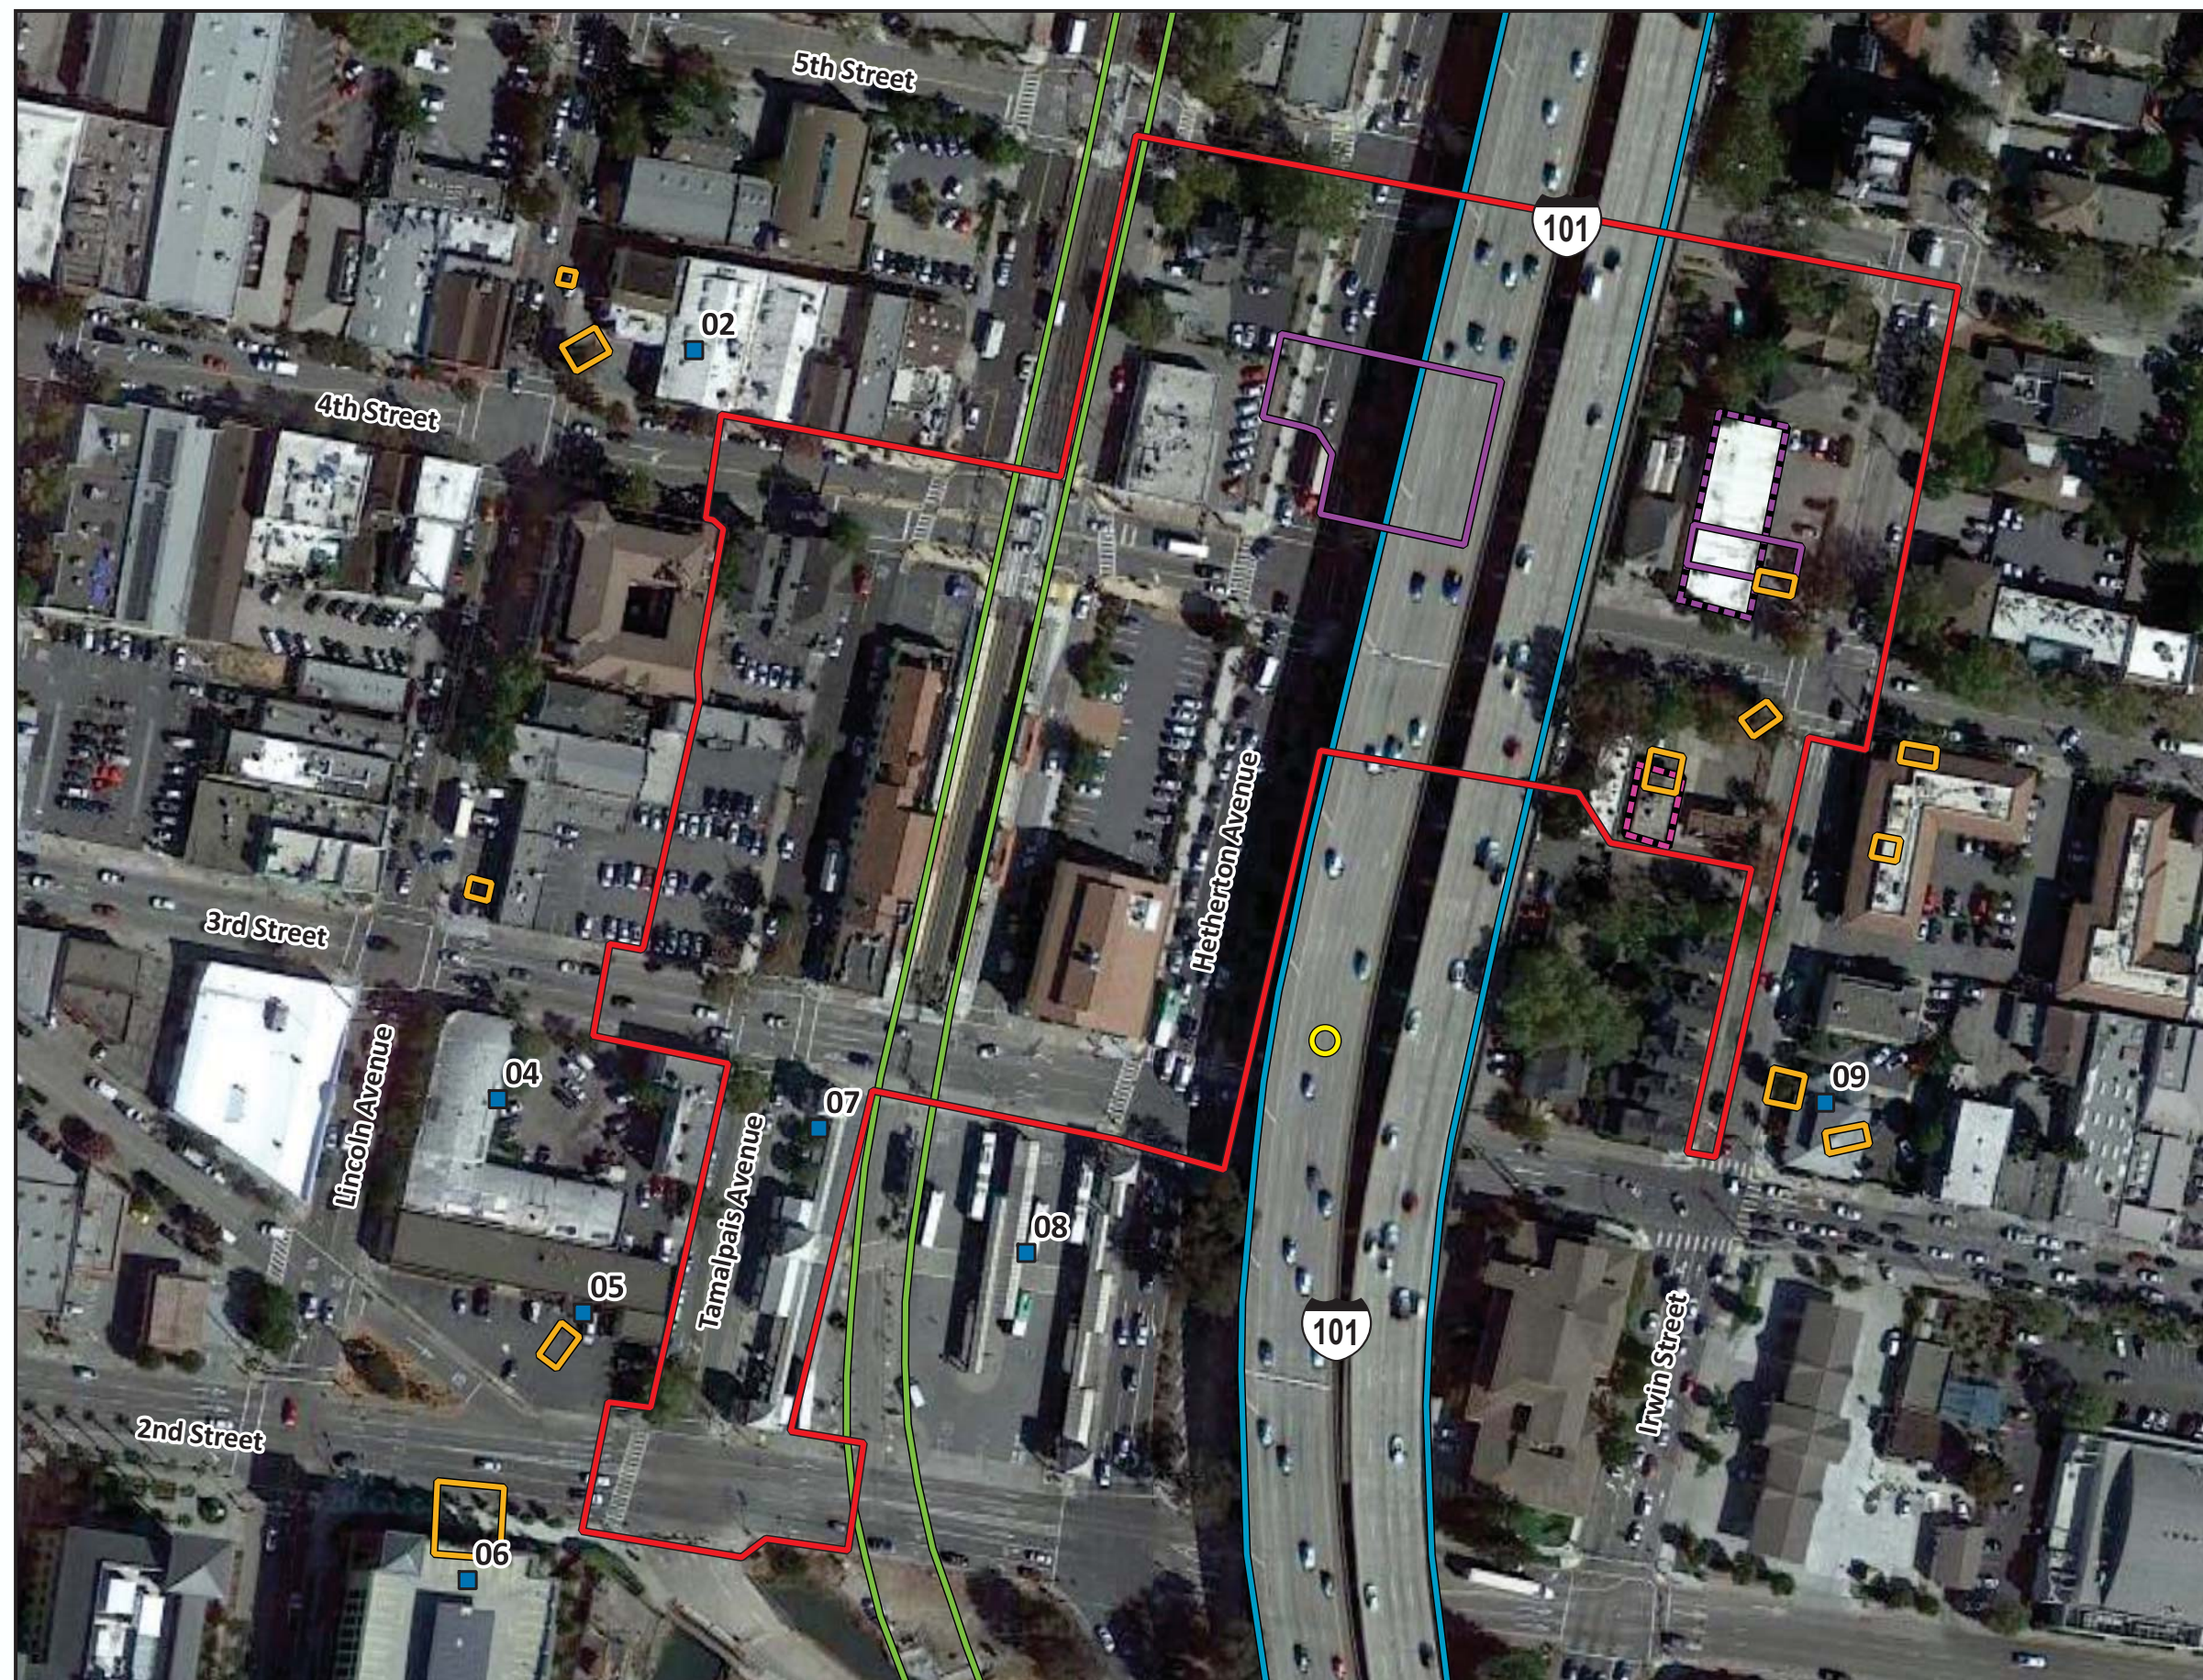
- Undocumented soil and/or groundwater contamination (if any) from gasoline service stations, automotive service buildings, a dry cleaner building, and an aboveground oil tank located within or adjacent to the project study limits (**Figure 5**).
- Residual soil and groundwater contamination (if any) from seven hazardous materials release sites located within or adjacent to the project study limits (Sites 02, 04, 05, 06, 07, 08, and 09 on **Figure 5**).
- Soil contamination below the existing U.S. Highway 101 viaduct (**Figure 5**) associated with ADL from historical vehicle emissions.
- Soil contamination along the existing railroad corridor (**Figure 5**) associated with historical railroad operations.

Once a preferred build alternative has been chosen and areas of excavation and demolition are determined, a Phase II Site Investigation should be performed prior to construction to investigate hazardous materials concerns related to soil, groundwater, and building materials that could be disturbed by the proposed project, as identified in this Phase I ESA. All environmental investigations for the project should be provided to the project contractor(s) to incorporate into their Health and Safety and Hazard Communication programs.
